Tissue Paper Factory

The Case

Sanuvox Customized Solution

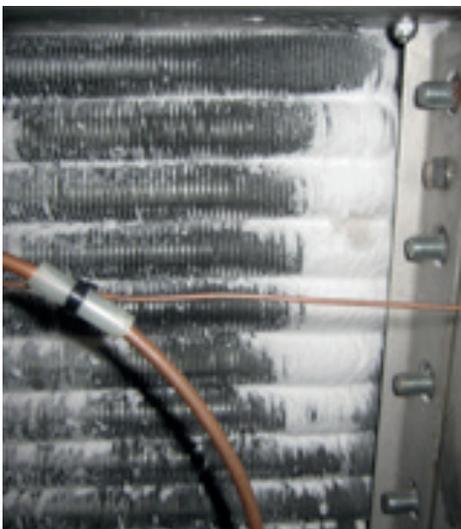
Client tentative of chemical cleaning
